Groundwater Monitoring Evaluation
~~Pine Bluff Arsenal~~ (PBA)
Pine Bluff, Arkansas
EPA I.D. NO. AR0213820707

December 16, 1985

SUMMARY

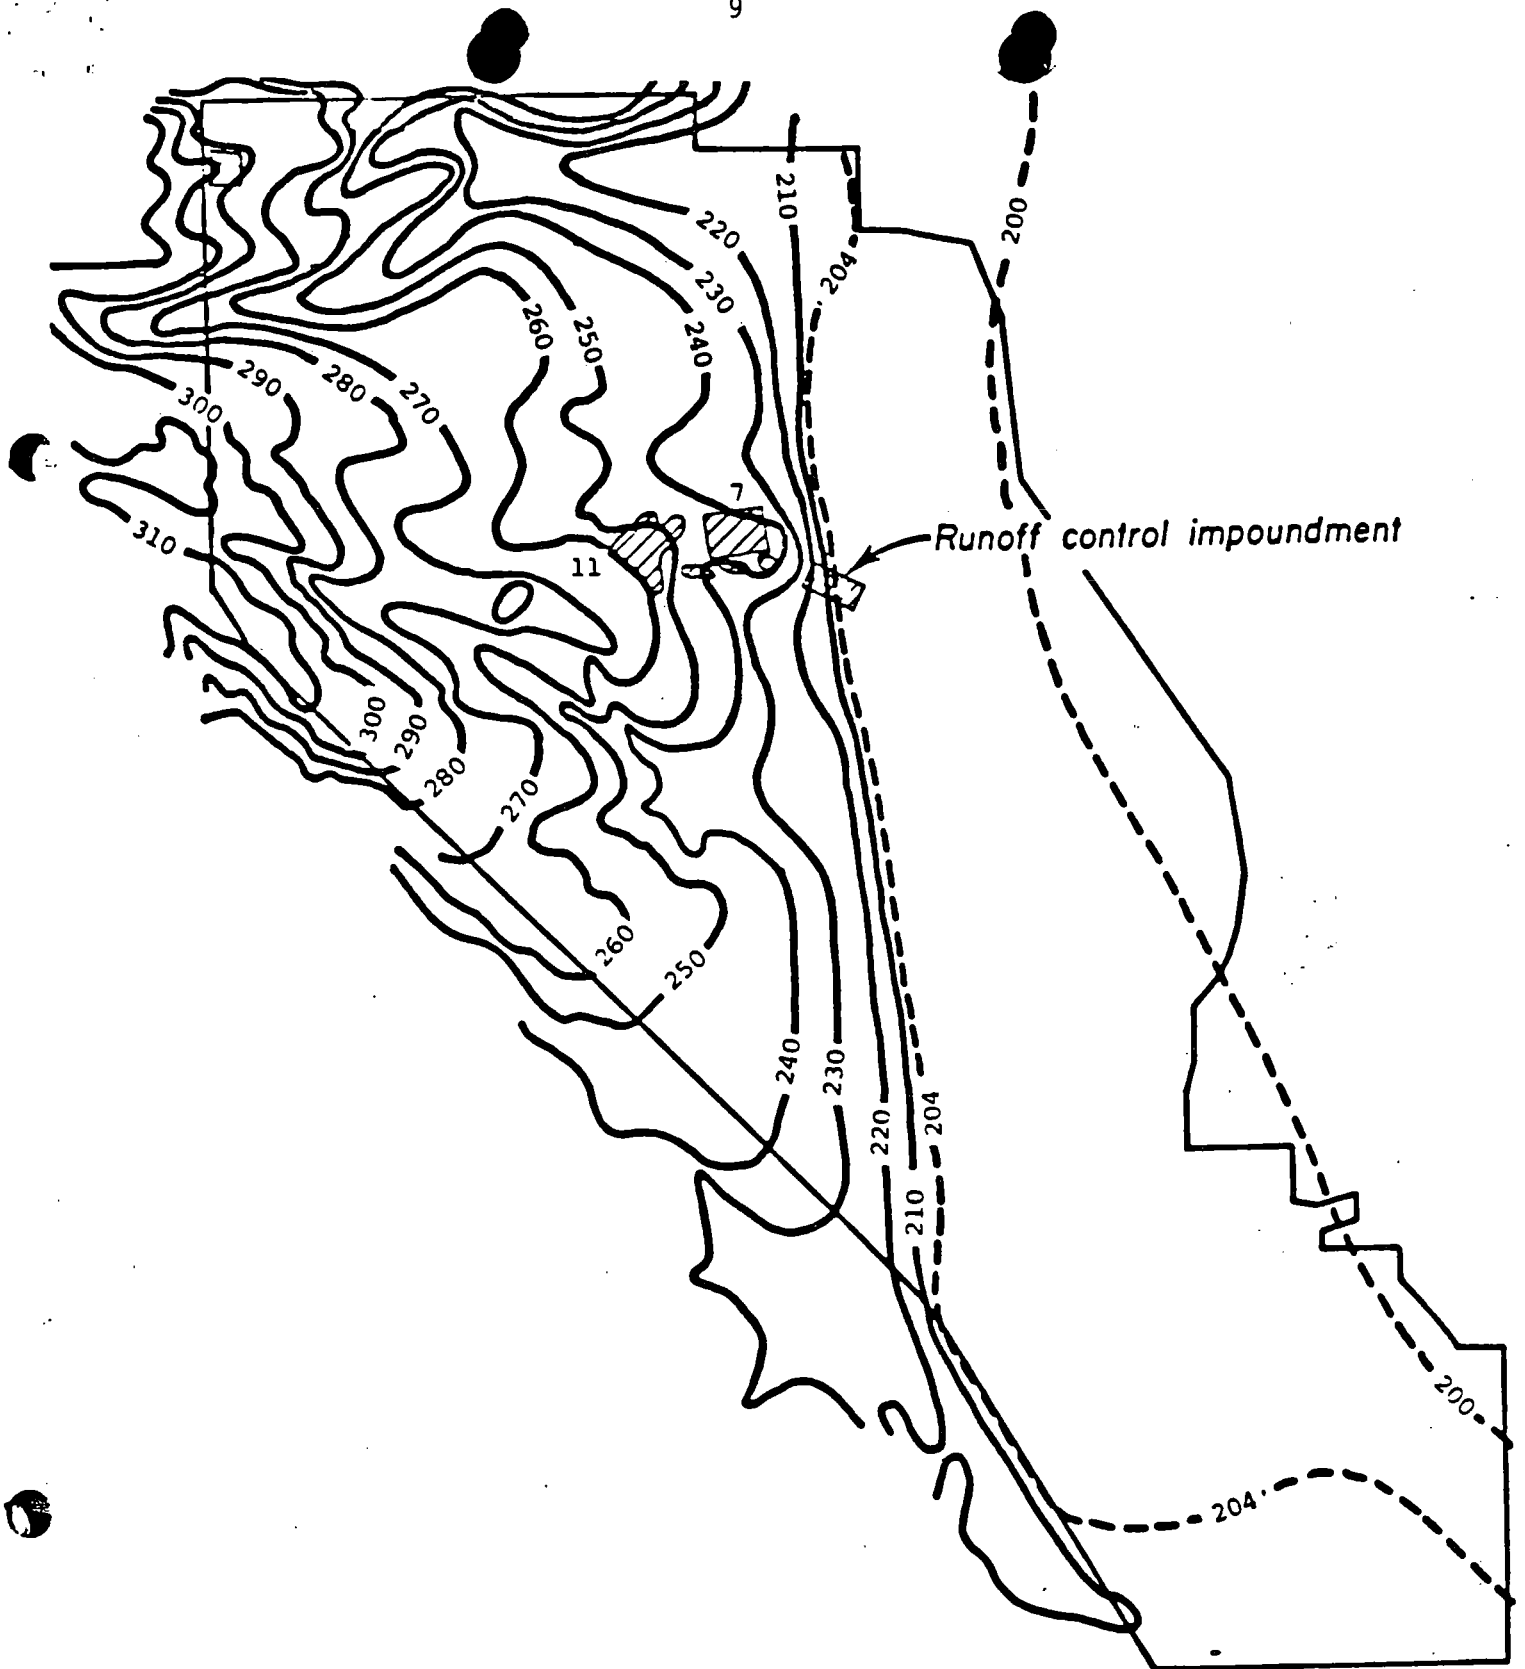
Figure 3. Location map showing the runoff control impoundment and the regional water table.

The surface run-off control impoundment was mistakenly considered to be a non-RCRA unit and therefore was not thoroughly evaluated during the inspection. This permitted impoundment (Figures 3 and 4) collects the run-off from soils around the chemical munition storage areas. PBA has installed a groundwater monitoring network around this impoundment.

Upon brief review of the water elevation, soil bore log, and well completion data submitted during and after the inspection, the following deficiency was noted: well completion logs were missing for Wells 189, 190, 191, and 192.

During the file review of the groundwater quality data (Groundwater Quality Background Assessment of the Run-off Control Impoundment, October 1985 by the Army Corps of Engineers) it was noted that the March 1985 groundwater sampling indicated groundwater contamination. This contamination is evidenced by low levels of organic compounds (pesticides) and elevated levels of chlorobenzene, TOC, and TOX. In addition, the pH values varied widely (5.6 - 11.6) which could indicate either improper well construction, improper sampling techniques, or groundwater contamination.

Groundwater sampling in August 1984 indicated that Well 190 (0.0570 mg/l) and Well 191 (0.0590 mg/l) contained lead in amounts that exceeded the EPA Primary Drinking Water Standard which is 0.050 mg/l. However, subsequent quarterly sampling has not exceeded the Primary Standard for lead.

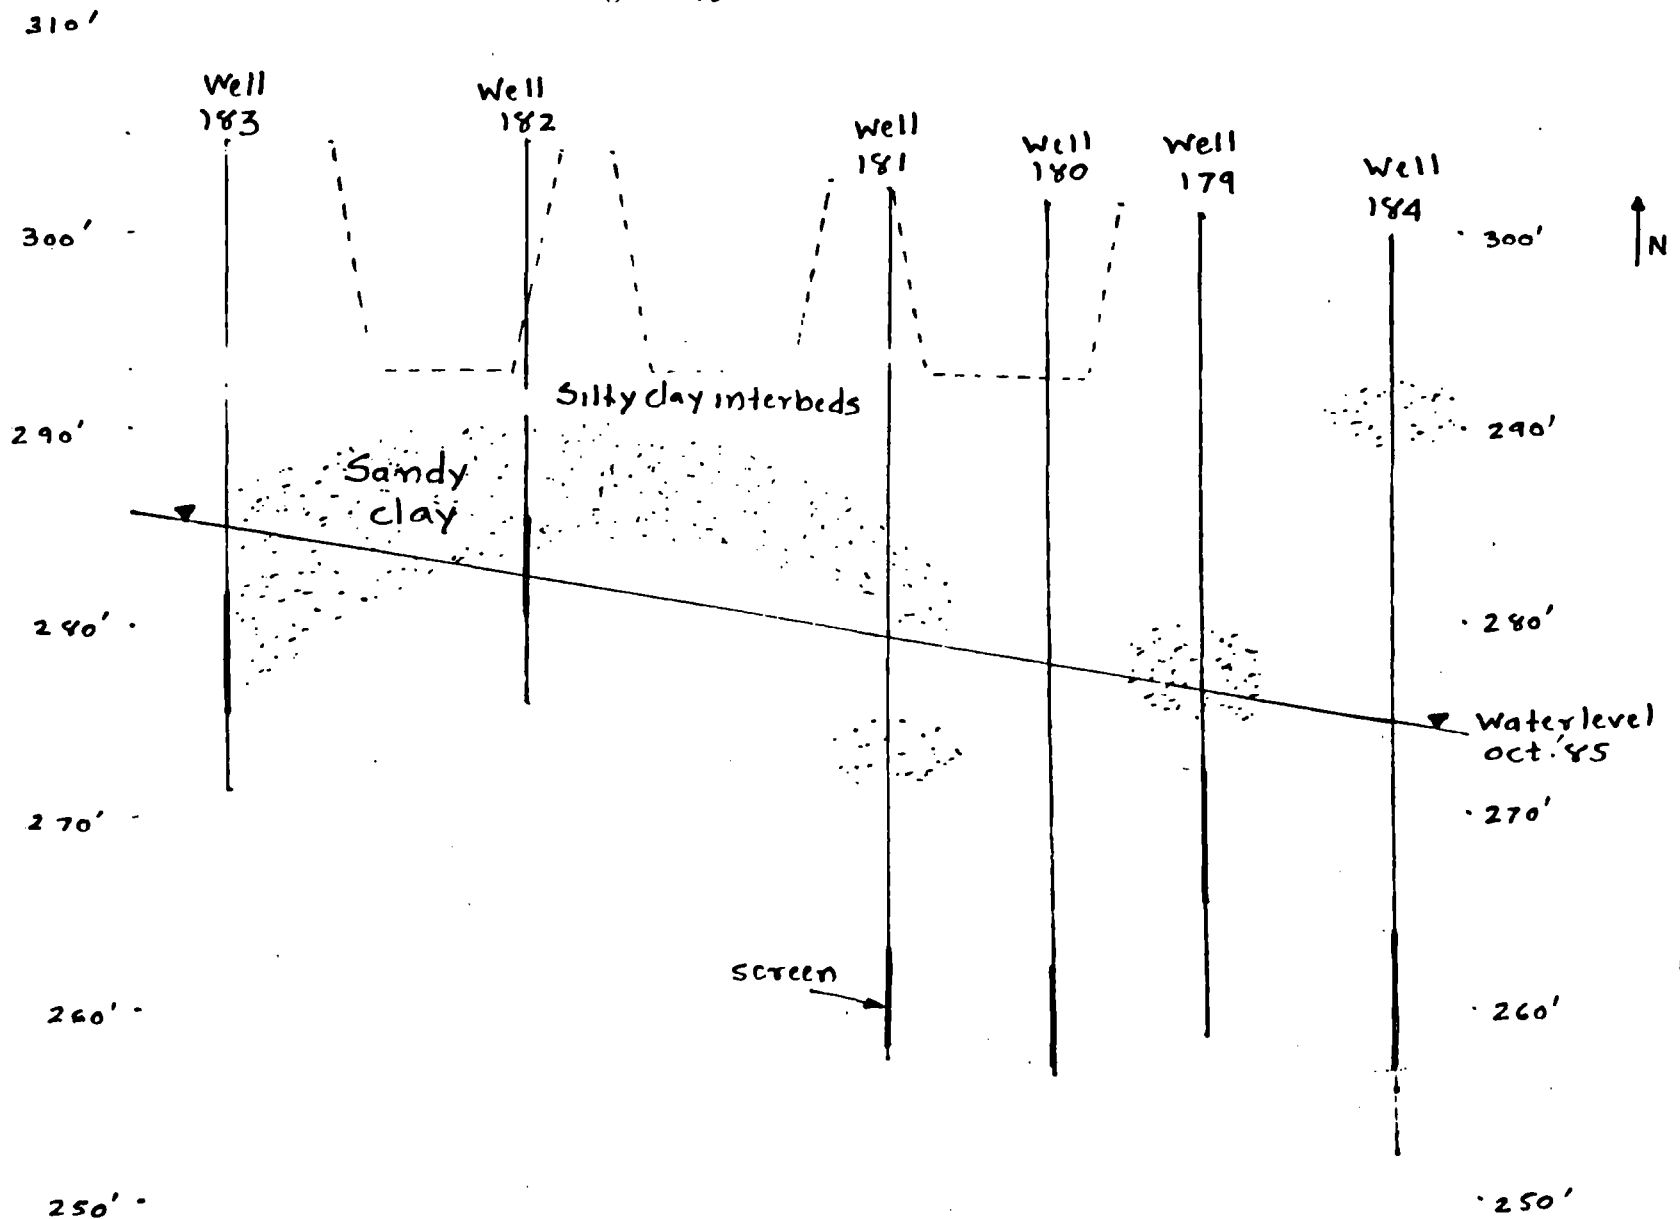
Figure 7.

Each well is constructed of 4-inch diameter PVC pipe with noncemented joints, 0.010 inch slotted PVC screen, high volume electric submersible pump, and permanent well caps. Each well is completed with a cement grout annular seal, a bentonite clay annular seal, and sand packs adjacent to the well screen which is 5 feet in length. More than half of the sand packs are at least 20 feet in length (Figures 7, 8, 9, and 10).

This well is inadequate because the excessive length of the sand packs (39 feet) causes excessive dilution which greatly decreases the ability of Well 184 to detect contaminants in the uppermost aquifer (Figure 8). Due to its location (downgradient of Well 178), Well 184 is not a necessary monitor well in this monitoring system (Figure 5).

The water table is located in both the sand/sandstone and the clayey silt units (Figures 7 - 10). The wells monitor both the sand/sandstone and the clayey silt units. The permeability of the sand/sandstone, clayey silt unit, and the clay aquitard is low. However, the sand/sandstone unit is more permeable and has greater groundwater velocity than the other two units. Decreased clay content in the sand/sandstone unit results in a increase in the permeability and groundwater velocity.
